# Manhole Inspection Summary

Manhole # S13GG2009MH

**Location** Address: **6101 EASTCLIFF DR**

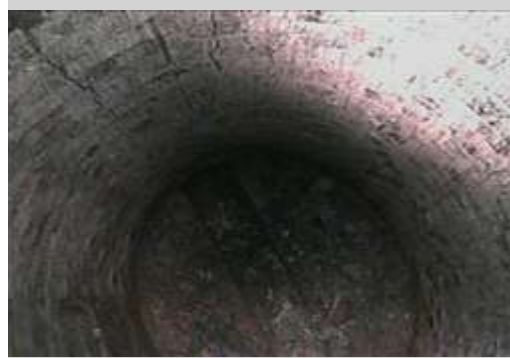
Top View

Infiltration: ☐ None ☒ **Joint** ☐ Cracks ☐ Mortar ☐ Roots ☐ Wall

Condition: ☐ Sound ☐ Cracked ☐ Root Intrusion ☐ Deteriorated ☐ Leaks ☒ **Debris**

Adjustment infiltration. Bench and Channel debris.

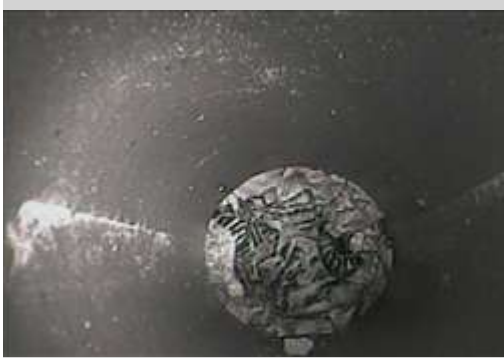
Plugged I6

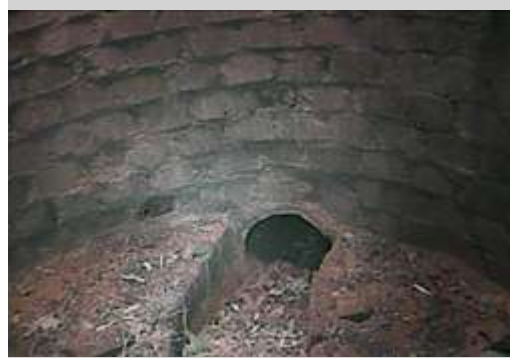
Defect

Infiltration: ☐ None ☐ Joint ☐ Cracks ☒ **Mortar** ☐ Roots ☒ **Wall**

**Bench** ☒ Exists Material: **Brick** ☐ Parged ☒ **Debris** (not Condition related)

Barrel infiltration. Bench and Channel debris.

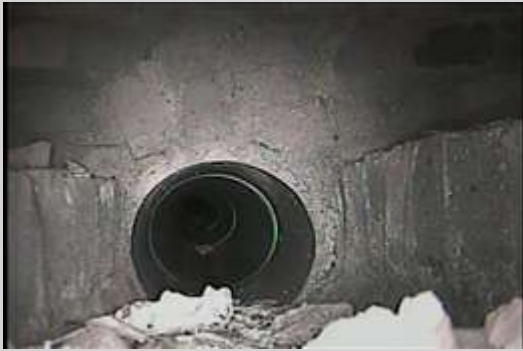
### 8 in. Circular Unknown Sewer Pipe Out @ 12 O'Clock

Deposits: ☐ None ☐ Mud ☐ Sludge ☒ **Debris** ☐ Grease

Silt Depth: **0** (in.) Deposits Extent: **Light**

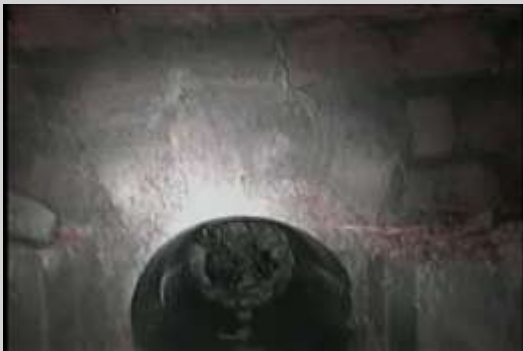
### 8 in. Circular Gravity Sewer Pipe In @ 6 O'Clock

Connects To: **Stub connection / abandoned**
